Manhole Inspection Summary

Manhole # S21AA_038MH

Insp Date: **9/11/07 7:47 AM**

Location Address: **1618 CHALK AVE** Cross Street: **MOUNT VINCENT**

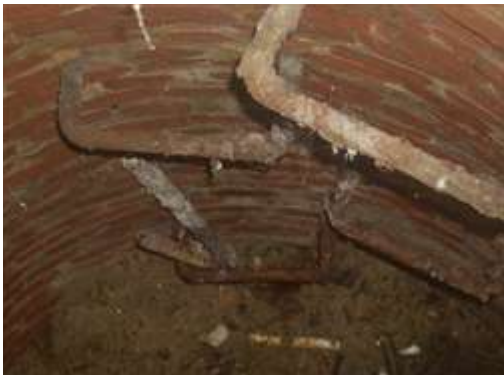
Defect 2

Steps Count: **5** Missing: **0** ☒ **Corroded**

CORRODED STEPS

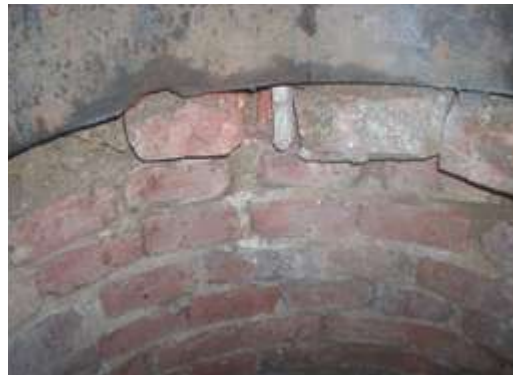
Defect 1

Corbel Material: **Brick** ☐ Parged Type: **Concentric/Eccentric**
Condition: ☐ Sound ☐ Cracked ☐ Root Intrusion ☒ **Loose Brick** ☒ **Deteriorated**
Infiltration: ☒ None ☐ Joint ☐ Cracks ☐ Mortar ☐ Roots ☐ Wall

LOOSE BRICKS AND DETERIORATION
OF THE CHIMNEY

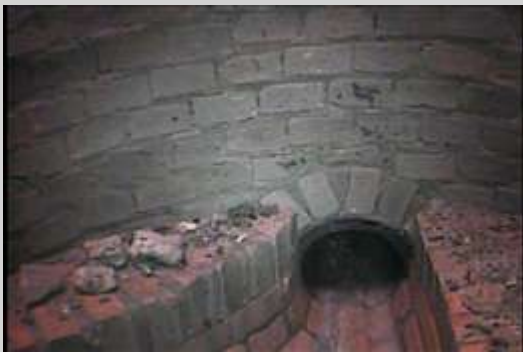
12 O'Clock Outflow

8 in. Circular Gravity Sewer
Pipe Out @ 12 O'Clock

Pipe Height: **8.4** (in.) Rod and Bar (Angled)
Pipe Material: **Clay** ☐ Pipe Lined
Invert Depth: **10.25** (ft.) Flow Characteristics: **Fast**
Deposits: ☒ None ☐ Mud ☐ Sludge ☐ Debris ☐ Grease
Silt Depth: (in.) Deposits Extent:
Infiltration: **None** Pipe Seal Cond: **Sound**

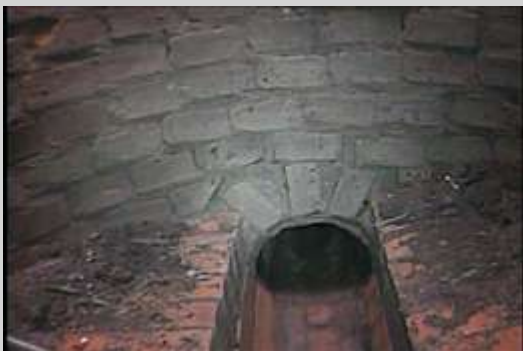
6 O'Clock Inflow

8 in. Circular Gravity Sewer
Pipe In @ 6 O'Clock

Pipe Height: **8.4** (in.) Rod and Bar (Angled)
Pipe Material: **Clay** ☐ Pipe Lined
Invert Depth: **10.10** (ft.) Flow Characteristics: **Slow**
Deposits: ☒ None ☐ Mud ☐ Sludge ☐ Debris ☐ Grease
Silt Depth: (in.) Deposits Extent:
Infiltration: **None** Pipe Seal Cond: **Sound**

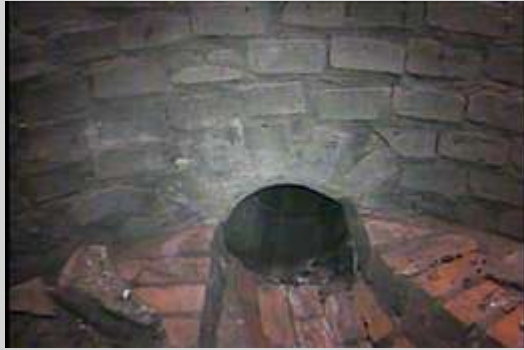
9 O'Clock Inflow

Infiltration: **None** Pipe Seal Cond: **Sound**
